USE OF GEOMEMBRANES IN BUREAU OF RECLAMATION CANALS, RESERVOIRS, AND DAM REHABILITATION

**December 1995
Technical Service Center**

**U.S. Department of the Interior
Bureau of Reclamation**

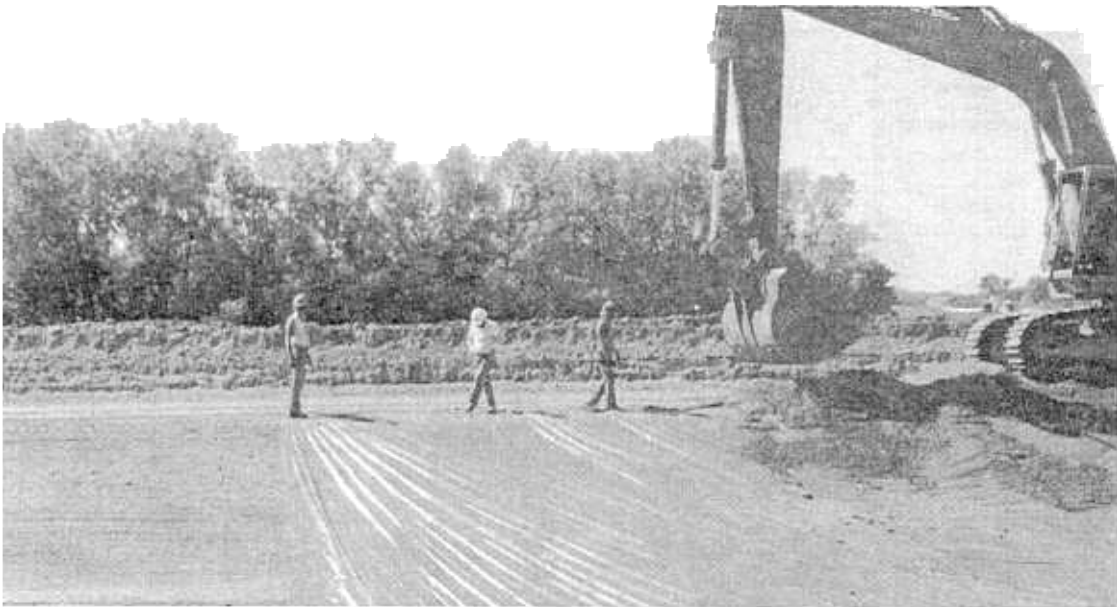
Figure 15. - View of PVC geomembrane clinging to canal subgrade like plastic fold wrap because of high temperatures, about 32 °C (90 °F), during installation in New Rockford Canal.

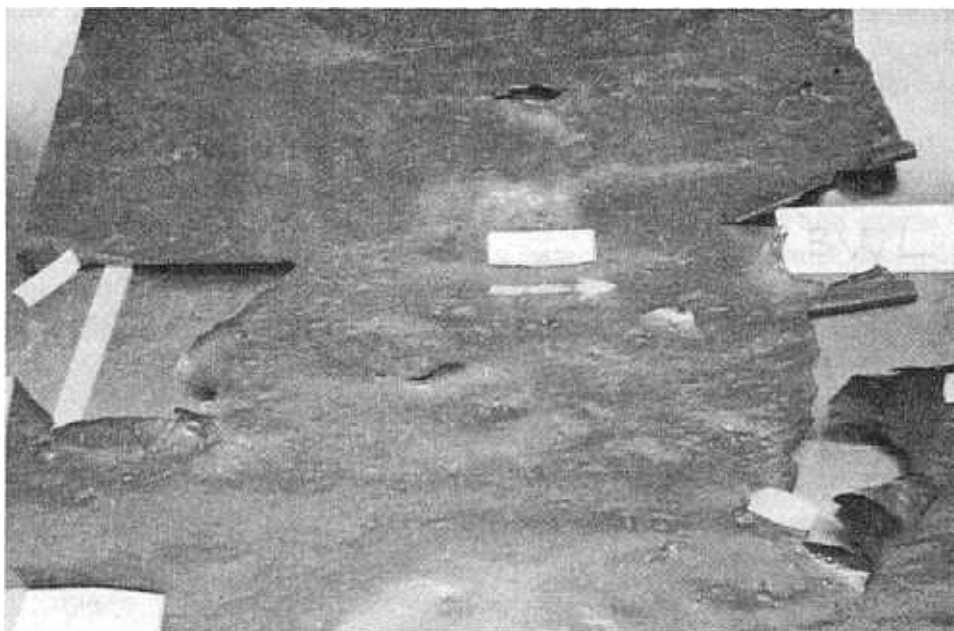
Figure 47. - View of 21-year-old field sample (22975) obtained from below waterline near station 1330+00, Helena Valley Canal, Montana. Sample has suffered some damage from animal traffic.

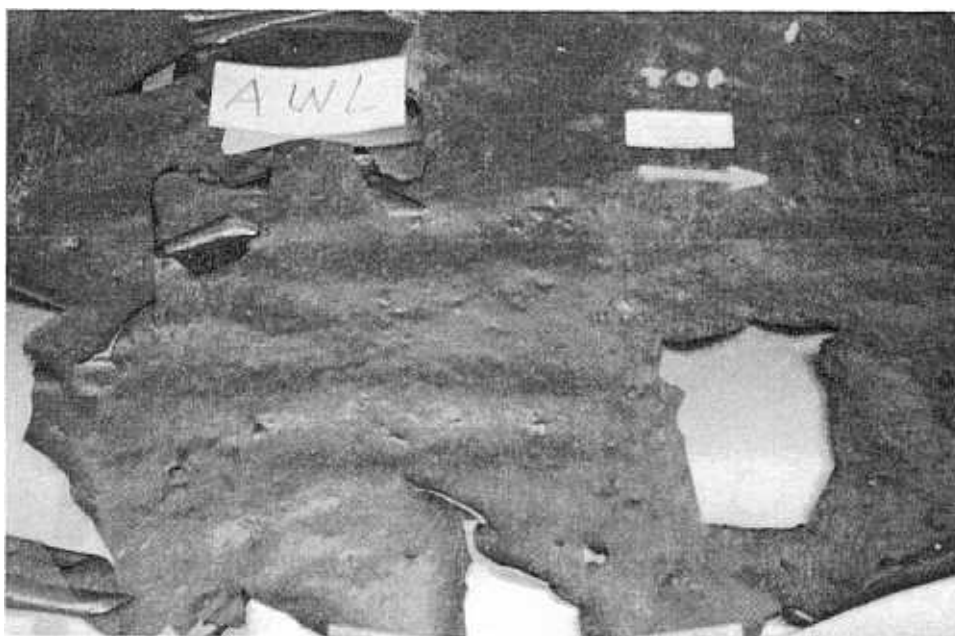
Figure 48. - View of 21-year-old field sample (22976) obtained from above waterline. As with sample shown on figure 47, it has also suffered damage from animal traffic.

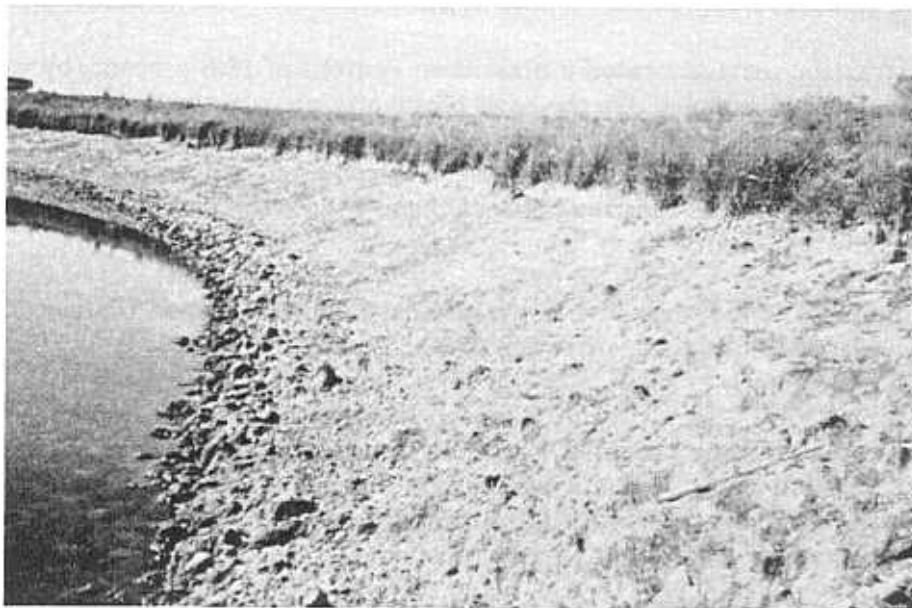
Figure 50. - East Bench Canal looking upstream from station 900+00. Sand and gravel cover in excellent condition. Cover depth was about 20.5 mm (18 in). Photograph taken October 20, 1983.

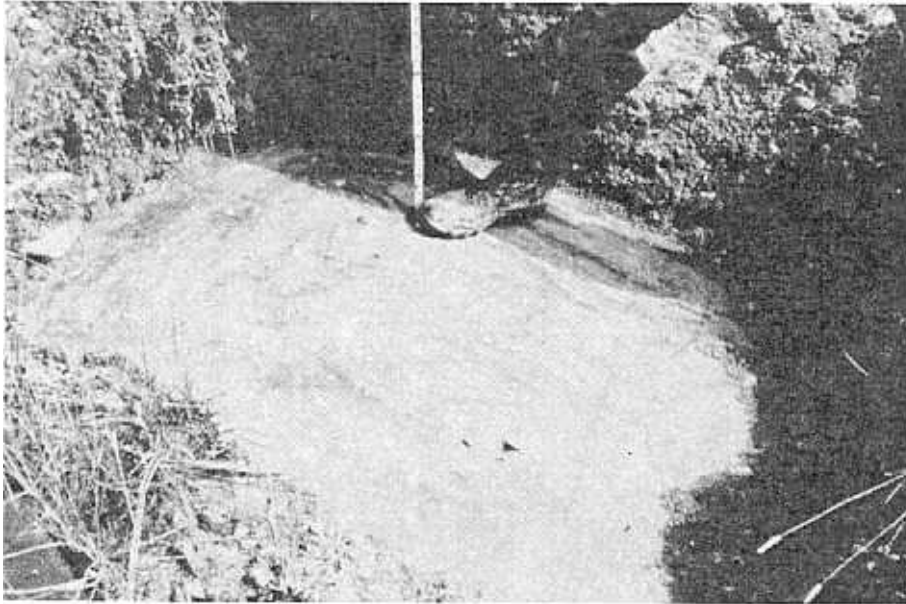
Figure 53. - Close-up view of upper lining sample No. 21211. Tears in lining were a result of removing cover material during sampling. Photographs taken October 20, 1983.

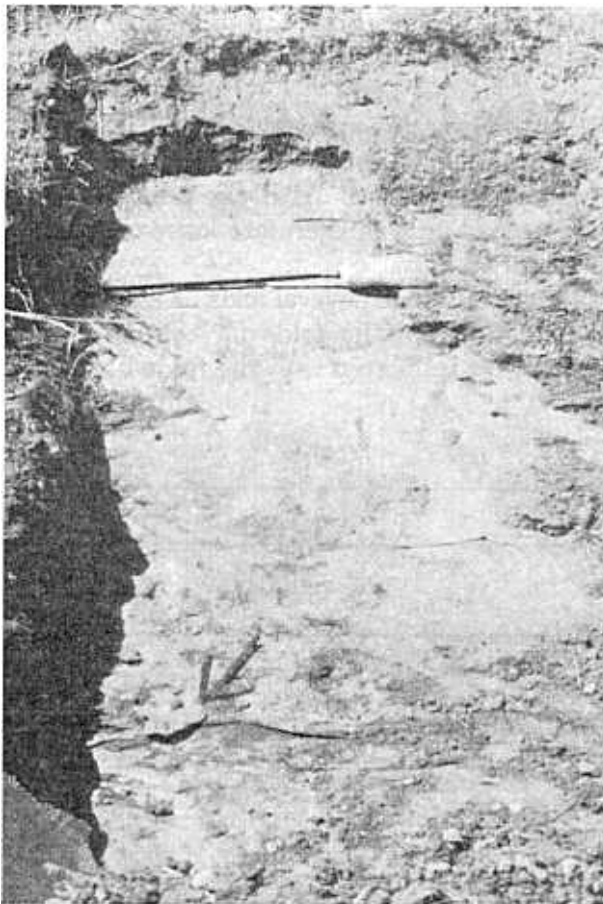
Figure 60. - View of PVC geomembrane on Bugg Lateral, Tucumcari Project, New Mexico, taken during 1980 field inspection. The geomembrane was uncovered near station 232+50 to show condition of geomembrane after 19 years of service. The broom indicates the approximate waterline. The tear shown at arrow was made by a shovel during the removal of the soil cover.

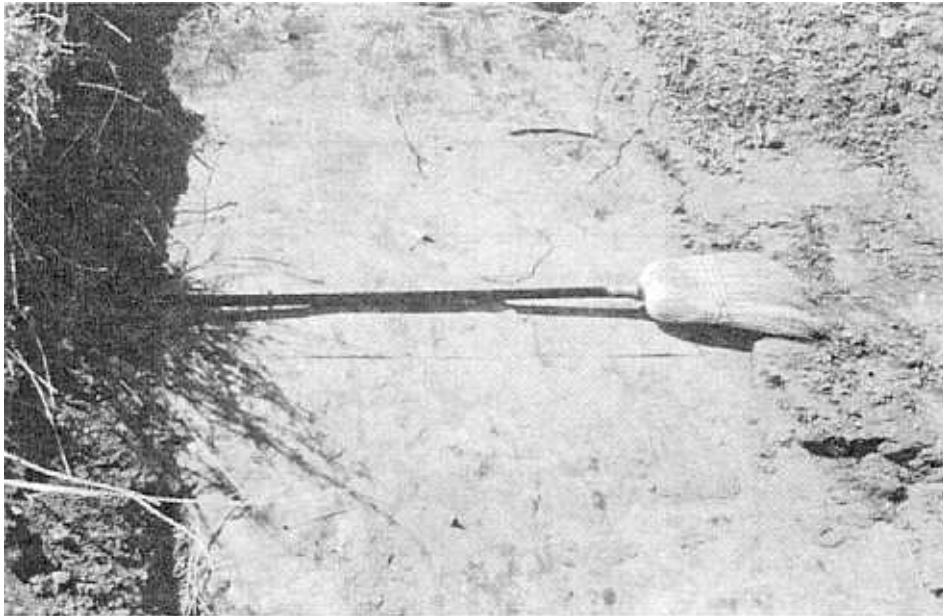
Figure 61. - Close-up view of 0.25-mm (10-mil) PVC geomembrane shown on figure 60. Note factory seam just below and running parallel to the broom. Above waterline, note the root penetration and tension tear in the upper right hand corner.

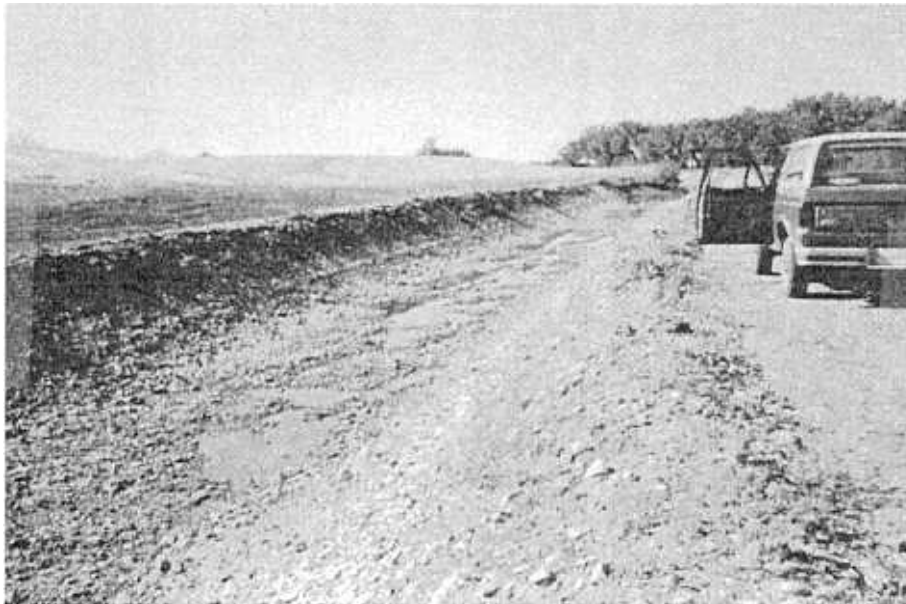
Figure 89. - Note standing water in test section. This area was left in "rough condition" after construction and not graded. The remaining test section was to grade and sloped properly to drain.

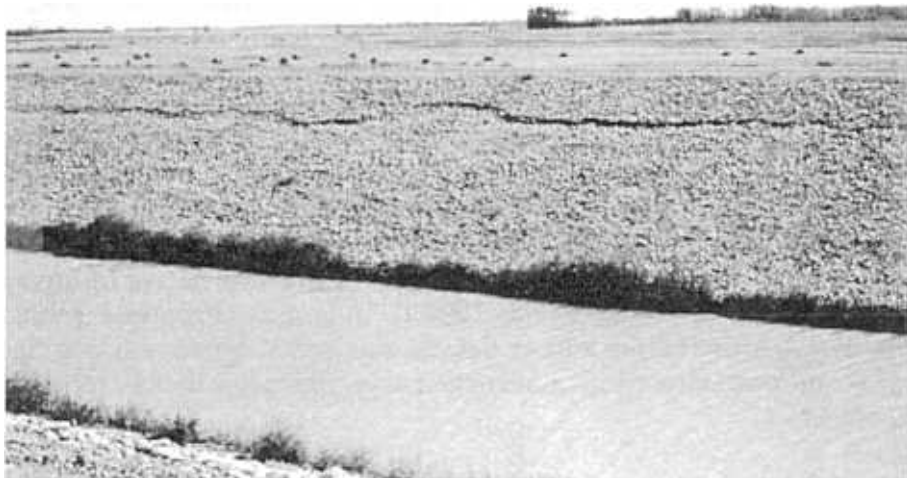
Figure 97. - View of protective soil cover slippage on New Rockford Canal, Reach 2. This slough has been classified as a type C: minor slippage or crack opening. Photograph was taken in September 1991.

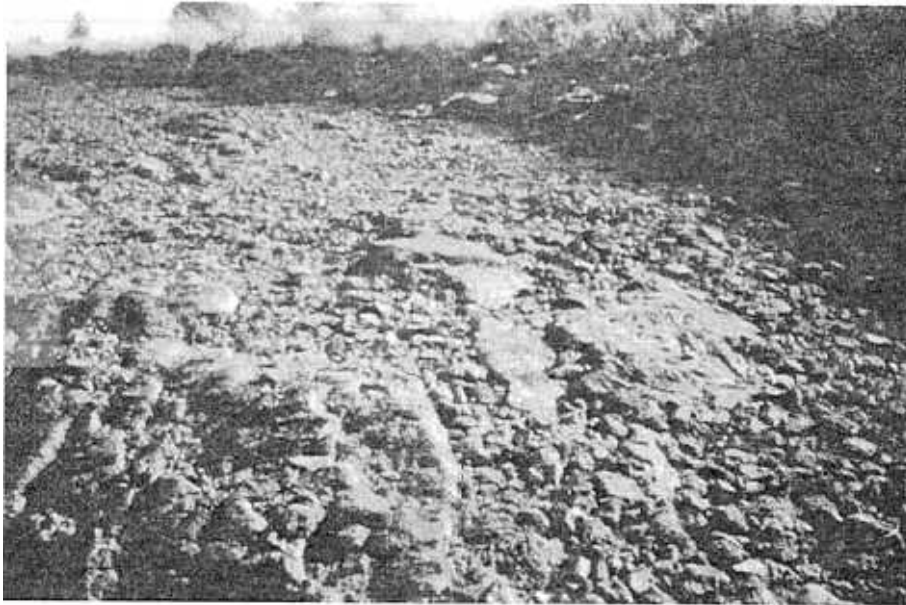
Figure 98. - View of rocky subgrade in North Unit Canal, Deschutes Project, Oregon. Such conditions present challenging preparation techniques for the installation of geomembranes.

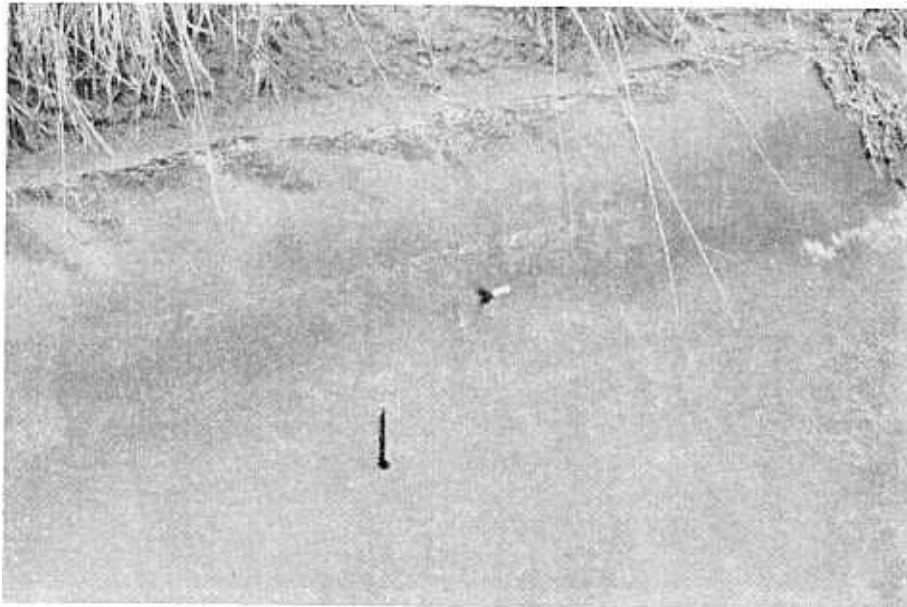
Figure 124. - Small hole and slits in left side of test section of HDPE geomembrane. Slits appear to have been caused by deer hooves. Photograph was taken May 29, 1991.

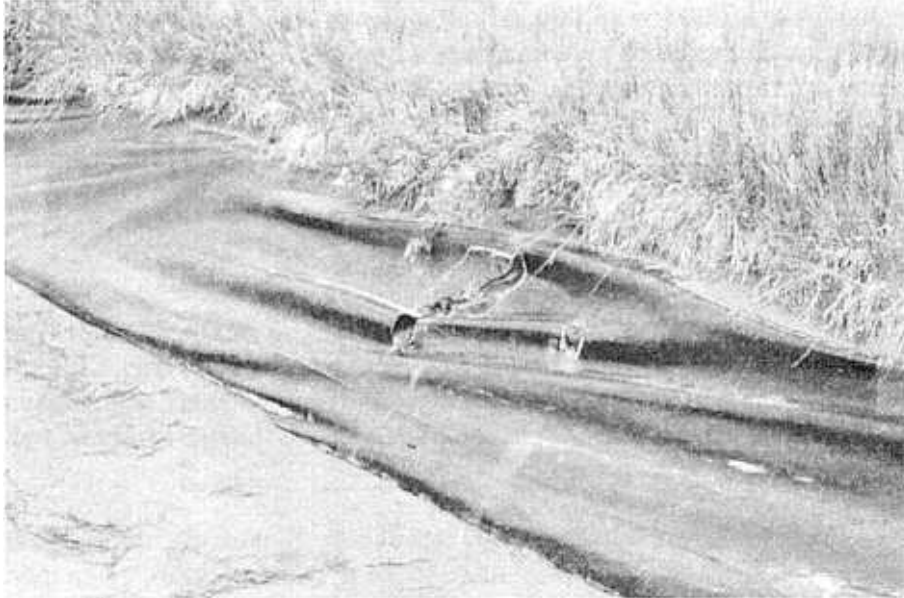
Figure 125. - Tears in HDPE geomembrane (right side) occurred during installation in 1983. Repairs made at the time of installation failed shortly after being made and no additional repairs have been attempted to date. Photograph was taken May 29, 1991.

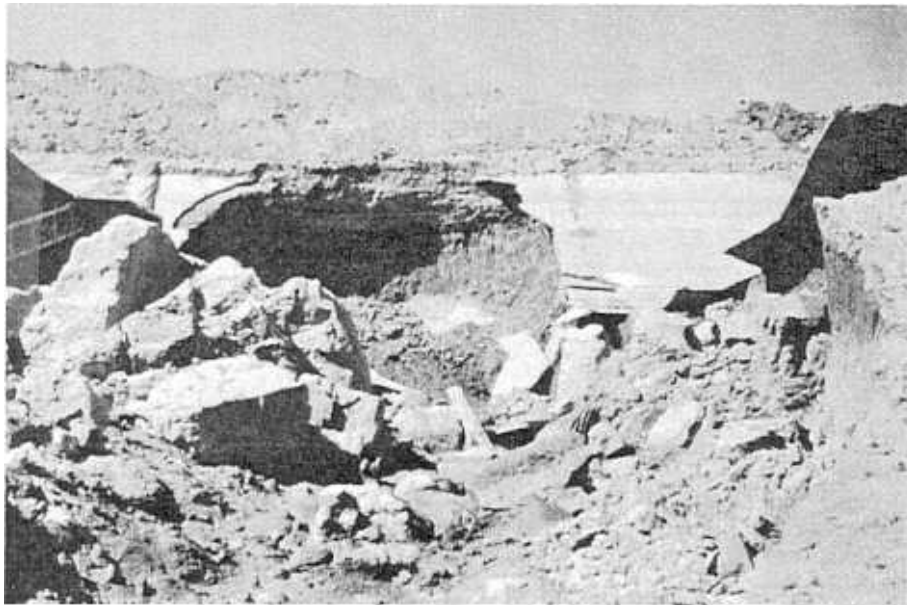
Figure 126. - Failure of Mirdan Canal, North Loup Division, Nebraska. The failure, near station 685+00, was caused by saturation and subsequent settlement of the low density, silty subgrade soils. The saturation was caused by leakage through frost-induced cracks in the concrete lining as shown on figure 127. Photograph taken July 1987.

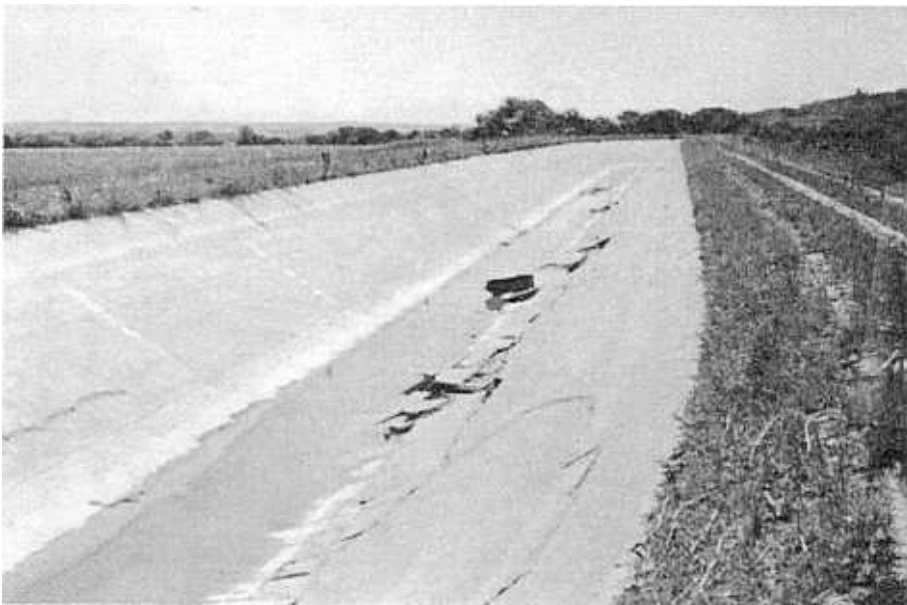
Figure 127. - Cracks in concrete lining in Mirdan Canal caused by frost heave.

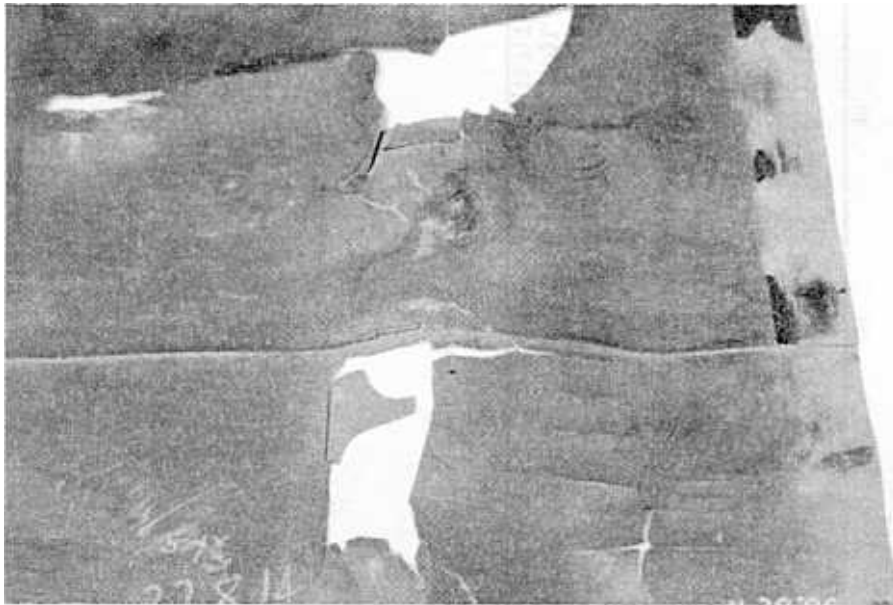
Figure 157. - Condition of 0.75-mm (30-mil) VLDPE sample after 5 years of outdoor exposure. Sample was in a very brittle condition.
